# Emergency Response to Transected I-125 Seed

Hamilton Health Sciences

# Case Study

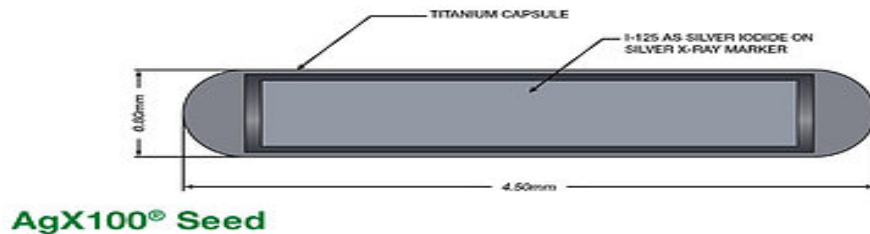
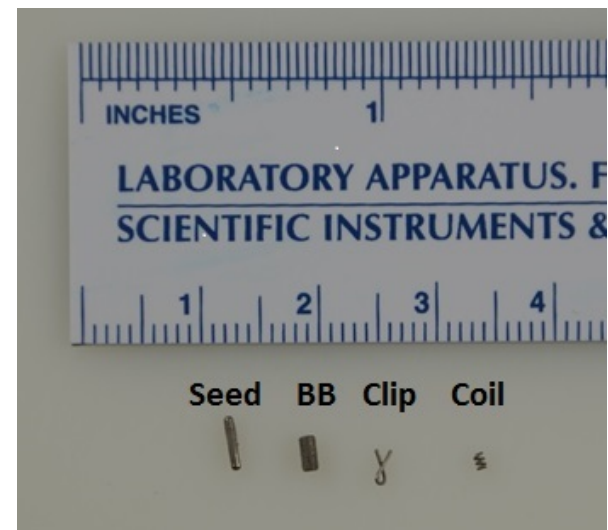
# I-125 Seed Description

- \* The I-125 seed device consists of a laser welded titanium capsule containing I-125 adsorbed onto a silver rod.

- \* Seeds are considered to be sealed source devices and are leak tested during manufacturing.
- \* A sealed source calibration certificate is provided containing apparent activity (radiation output of the seed, not contained activity!)

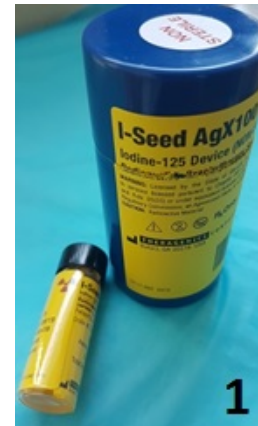
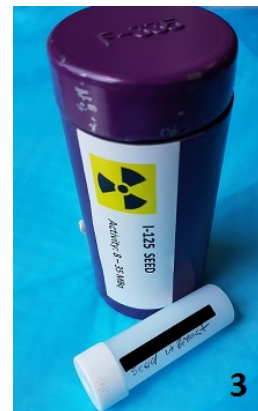
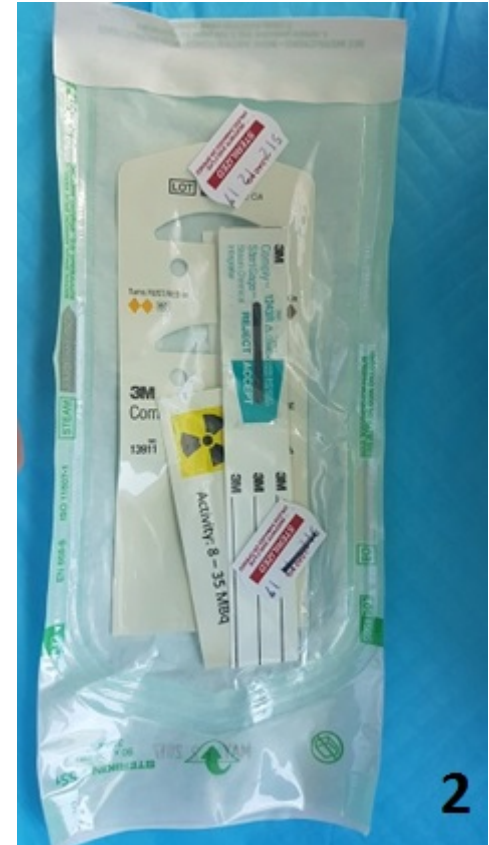
# “Movement” of the I-125 seed at HHS

- \* Delivered to Nuclear medicine<sup>1</sup>  
↓
- \* Sterilization in MDRD<sup>2</sup>  
↓
- \* Storage in Nuclear Medicine  
↓
- \* Implantation in Breast Assessment Centre  
↓
- \* Excised in Surgical unit  
↓
- \* Removed in Pathology  
↓
- \* Stored in Nuclear Medicine for decay<sup>3</sup>

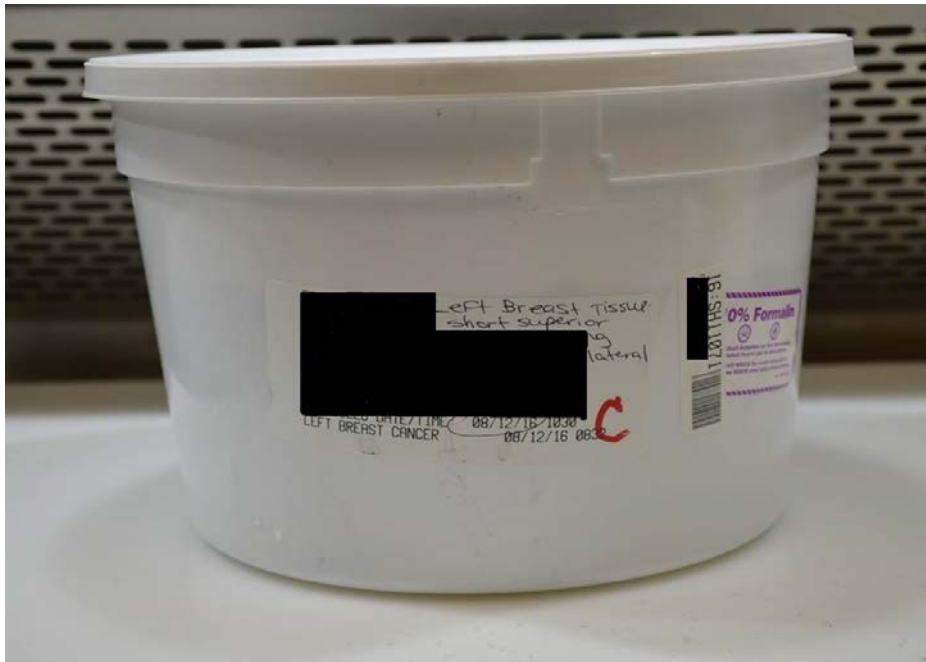
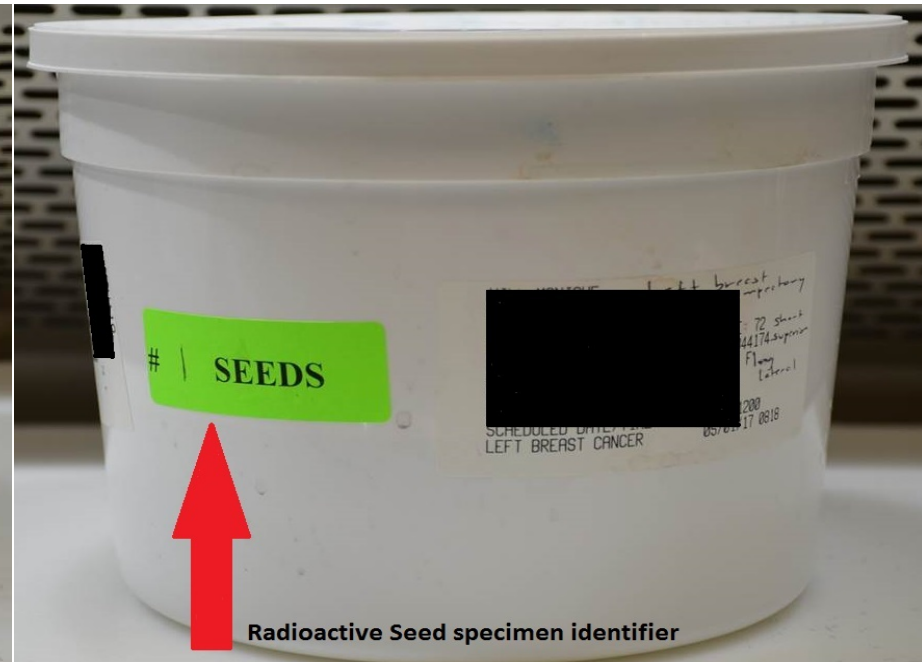
- \* Pathology department used to be notified of the seed presence only via a sticker that was placed by the OR staff on the specimen container.

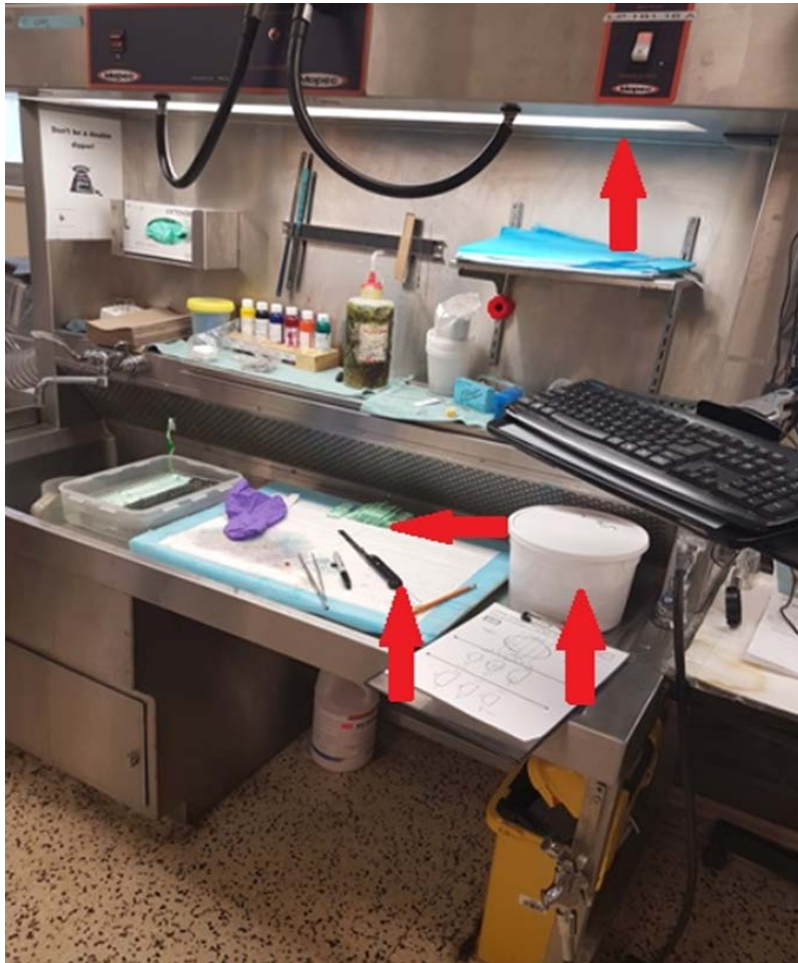
- Fume hood was operational.
- Breast tissue container did not have the “sticker”.
- One technologist working on the breast specimen utilizing standard blade!
- Transected seed placed in sealed container.
- Proper PPE utilized.

- Inform RSO immediately.
- Monitoring for contamination of all personnel in pathology lab.
- Monitoring of all items for contamination.
- Inform pathology staff of potential thyroid screening.

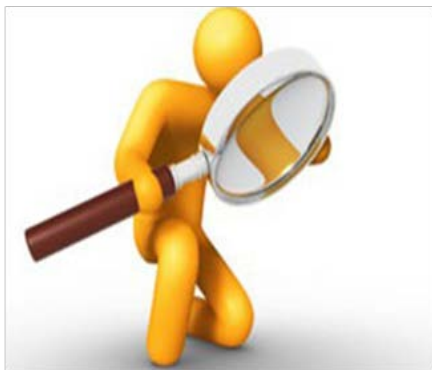
# Follow up

- \* Storage of all contaminated items in Nuclear Medicine.
- \* Breast sample tissue decontamination utilizing water.
- \* Soaking tissues in formalin for 3 days in an attempt to further reduce tissue contamination.
- \* Determination of probe's efficiency for I-125 detection.
- \* Perform an experiment with Pathology on decayed I-125 seed.

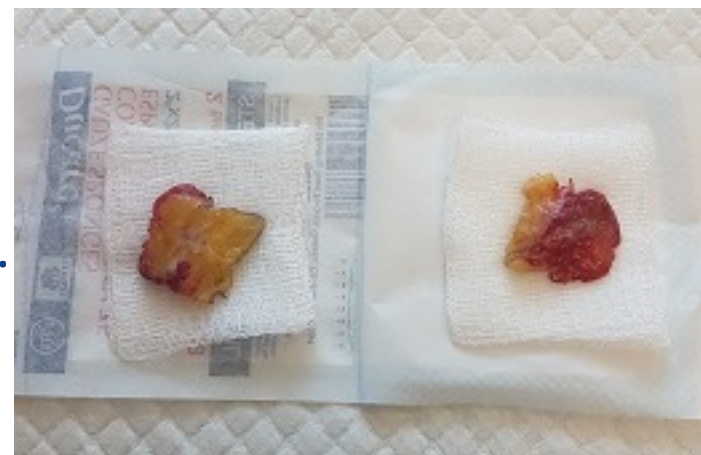
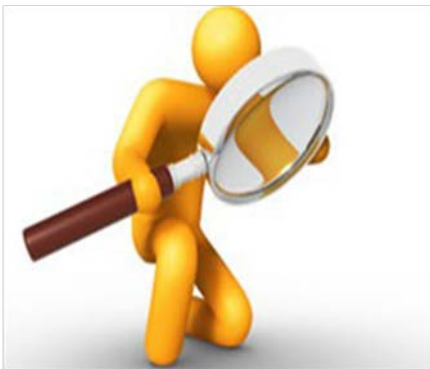
- \* Retrieved transected seed was 8.65MBq.  
Intact seed assayed just prior to localization was 8.04MBq!
- \* Of all the tissue slices that were generated in pathology, only 2 have been found to be contaminated with I-125.
- \* Discarding any breast tumour tissues was not an option.  
All samples had to be ready for analysis by the Pathologist.
- \* Initial monitoring indicated total spilled activity of 200 kBq (~ 1% of the total activity).

- \* After washing the samples with water for 20 min, both samples had a total of 28 kBq of I-125 (~10x decrease from initial activity).
- \* To further reduce I-125 content, tissue samples had been left in formalin solution for 72 hours.
- \* Soaking in formalin solution did not help.
- \* Given that samples were a fraction of an EQ, samples were sent for processing...

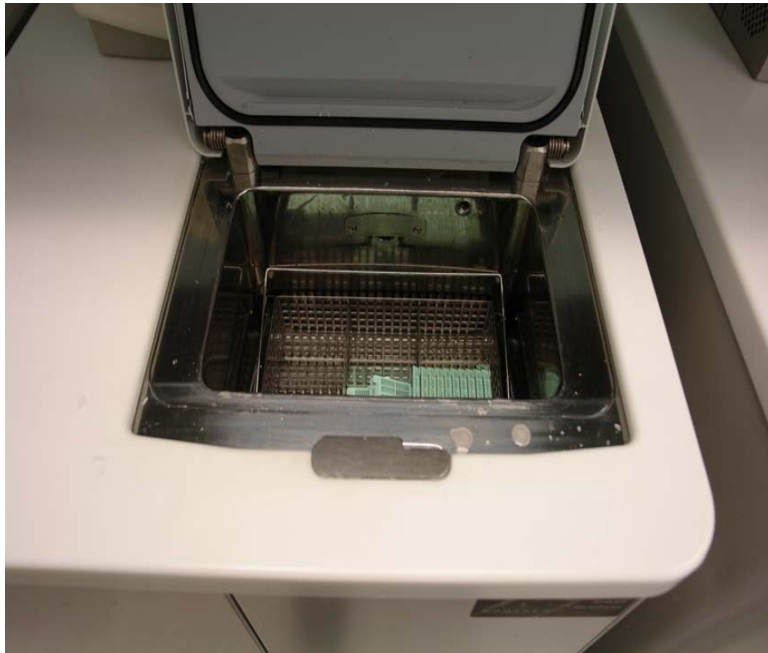
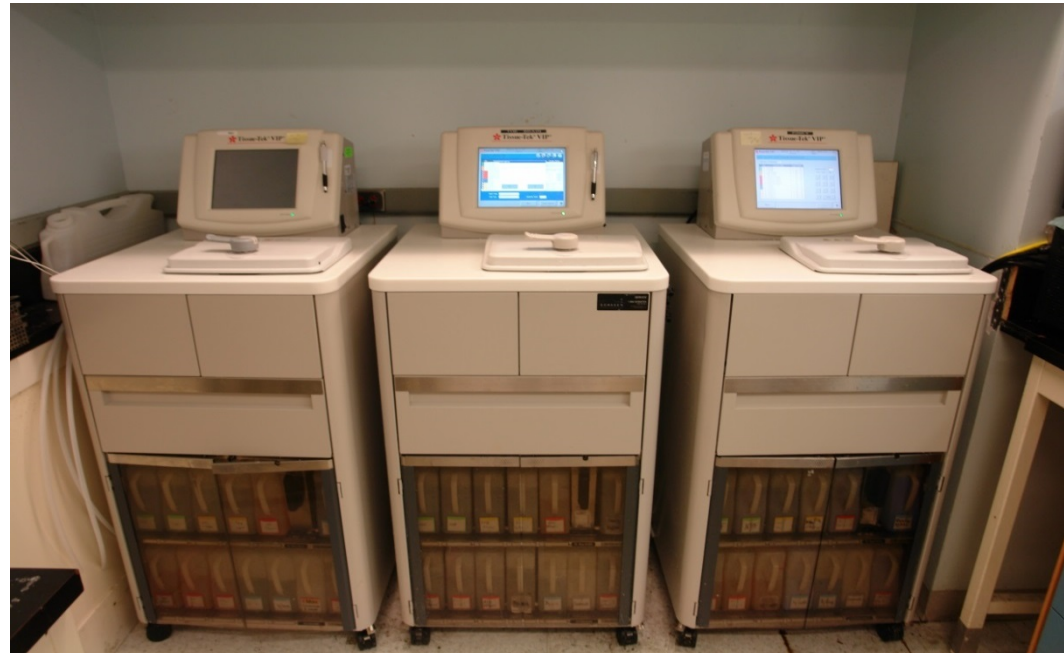
# Tissue processing

- \* Processor puts the sample through a variety of 'baths' to prepare sample tissues for processing.
- \* Cassette is placed in a rack for tissue processing, embedded in wax to be cut for slides and stained.

- \* RST was present during the processing.
- \* Lots of communication with the pathology technologist before the samples came in for processing to explain the situation.
- \* Provided assurance that pathology technologist was safe to handle radioactive samples using standard PPE.  
(wear gloves and a lab coat)
- \* RST scanned the equipment after the sample was processed for contamination and found no detectable activity.
- \* Although not necessary, the blade on the cutter after the samples were processed was changed.
